Aboite

GENERAL INFORMATION

Address	5630 Coventry Lane Fort Wayne, IN 46804
Building Size	13,319 SF
Site Area	2.20 Acres
On Site Parking	37
Year Built	1990
Original Architect	Moake & Associates

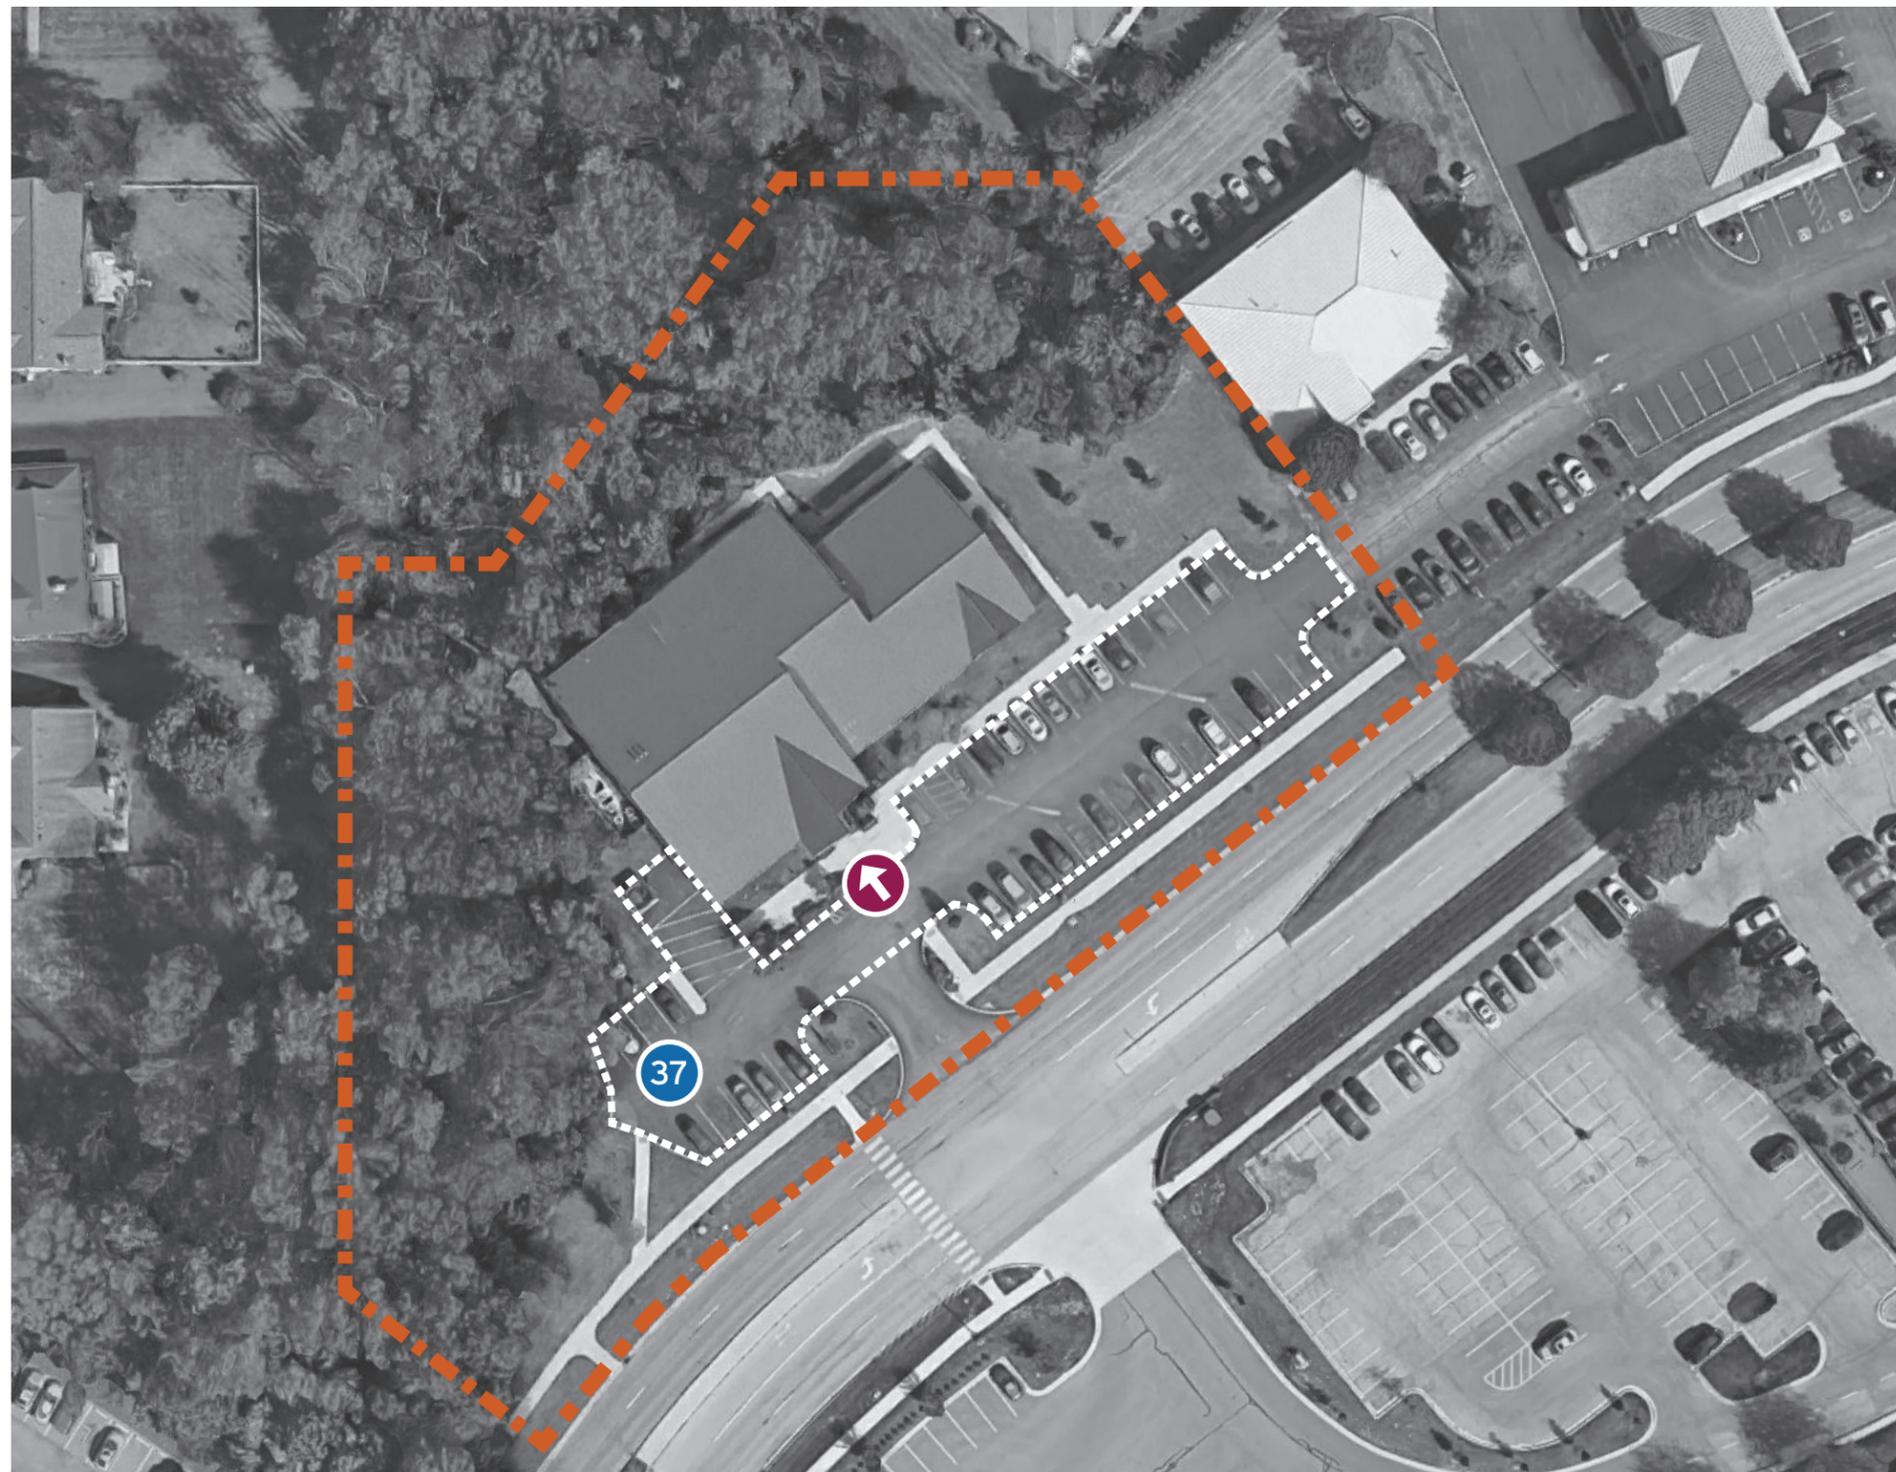
Site Plan

The branch is easily identifiable from Coventry Lane, however this is a secondary road at the back of the Village at Coventry, a large mixed use retail development on the primary route, Jefferson Boulevard. The library is not visible from Jefferson Boulevard and there is no signage at the Coventry Lane intersection indicating the library location.

The parking lot is too small, and the configuration at a busy retail development requires overflow parking at adjacent lots across Coventry Lane requiring a hazardous street crossing to access the branch.

The site has a small grass yard to the north, but not sufficient for programming or expansion. The ravine to the south and west of the branch further limit any growth or development.
