# Grabill

## GENERAL INFORMATION

## BRANCH CONDITION

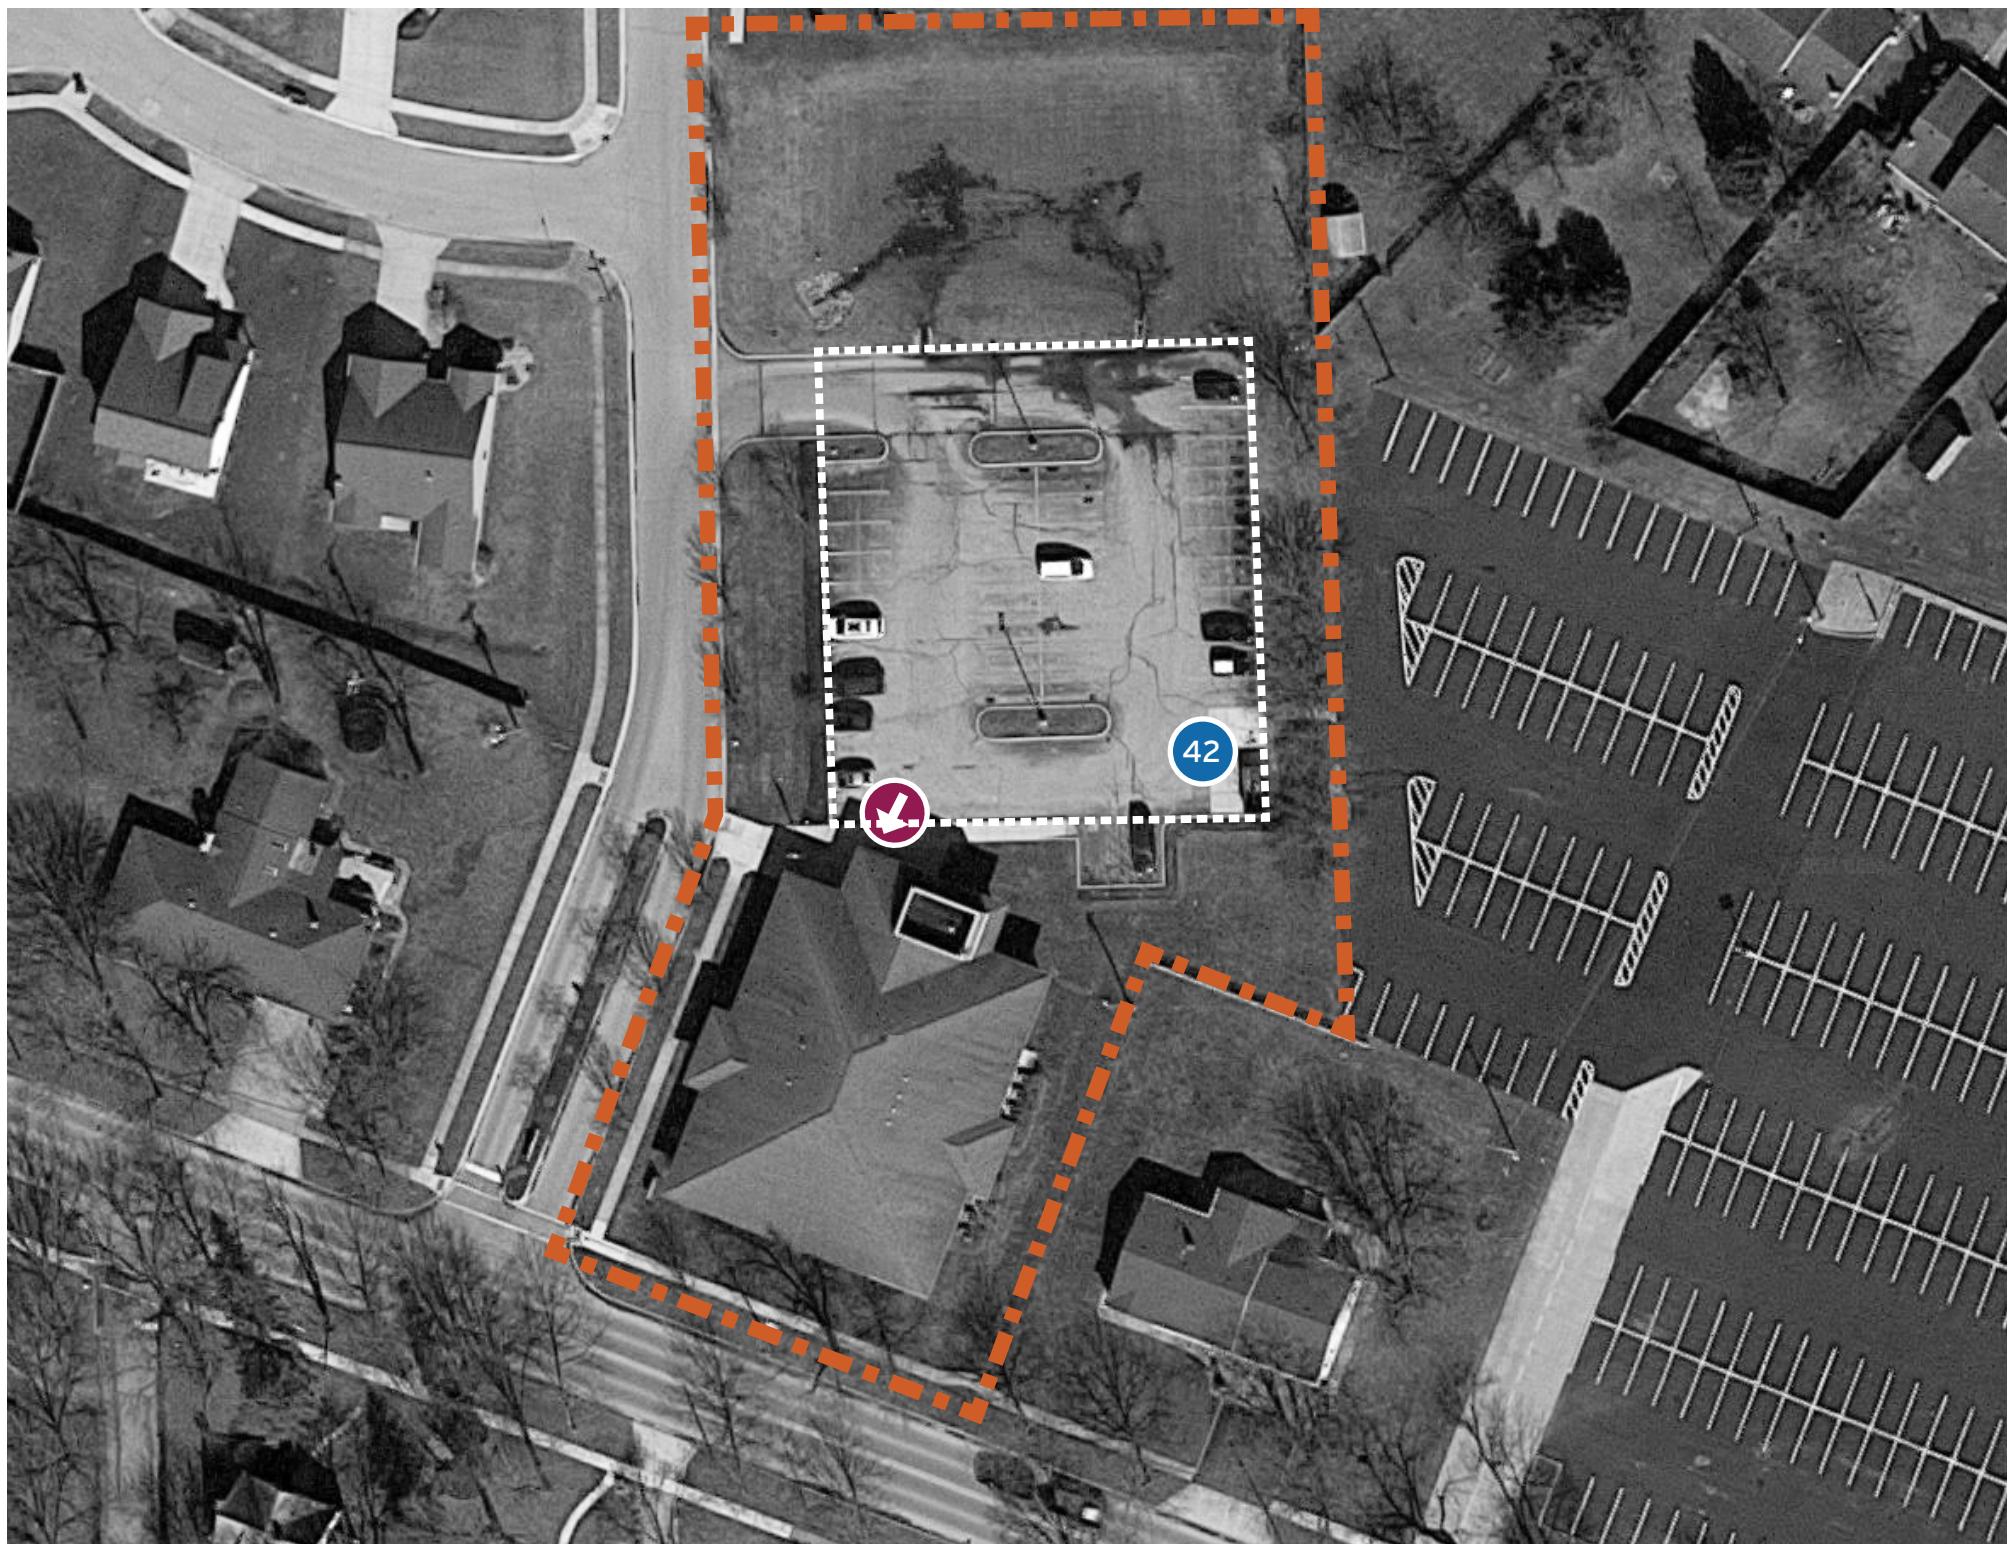
Site Plan

The branch has good visibility from Grabill Road, and the building design projects some presence as a library in a mixed but mostly residential part of Grabill just west of downtown. Parking is accessed off Grabill Road via Illinois Street immediately west of the library. The lot includes 42 spaces, a capacity that was not noted as a concern for the library.

The lot entrance location and configuration can cause some backup when cars are leaving and entering at the same time. Additionally, the first island location creates a tight turn, and many drivers run over the curb. The spaces dedicated for accessible parking are far from the entrance with an awkward path from vehicles.

The site does not include green space for outdoor programming. The available space within the property to the north is reserved for stormwater detention.

The property could accommodate expansion to the north, but this would require the stormwater detention to be built underground assuming parking would cover the current open detention area.
