Monroeville

GENERAL INFORMATION

BRANCH CONDITION

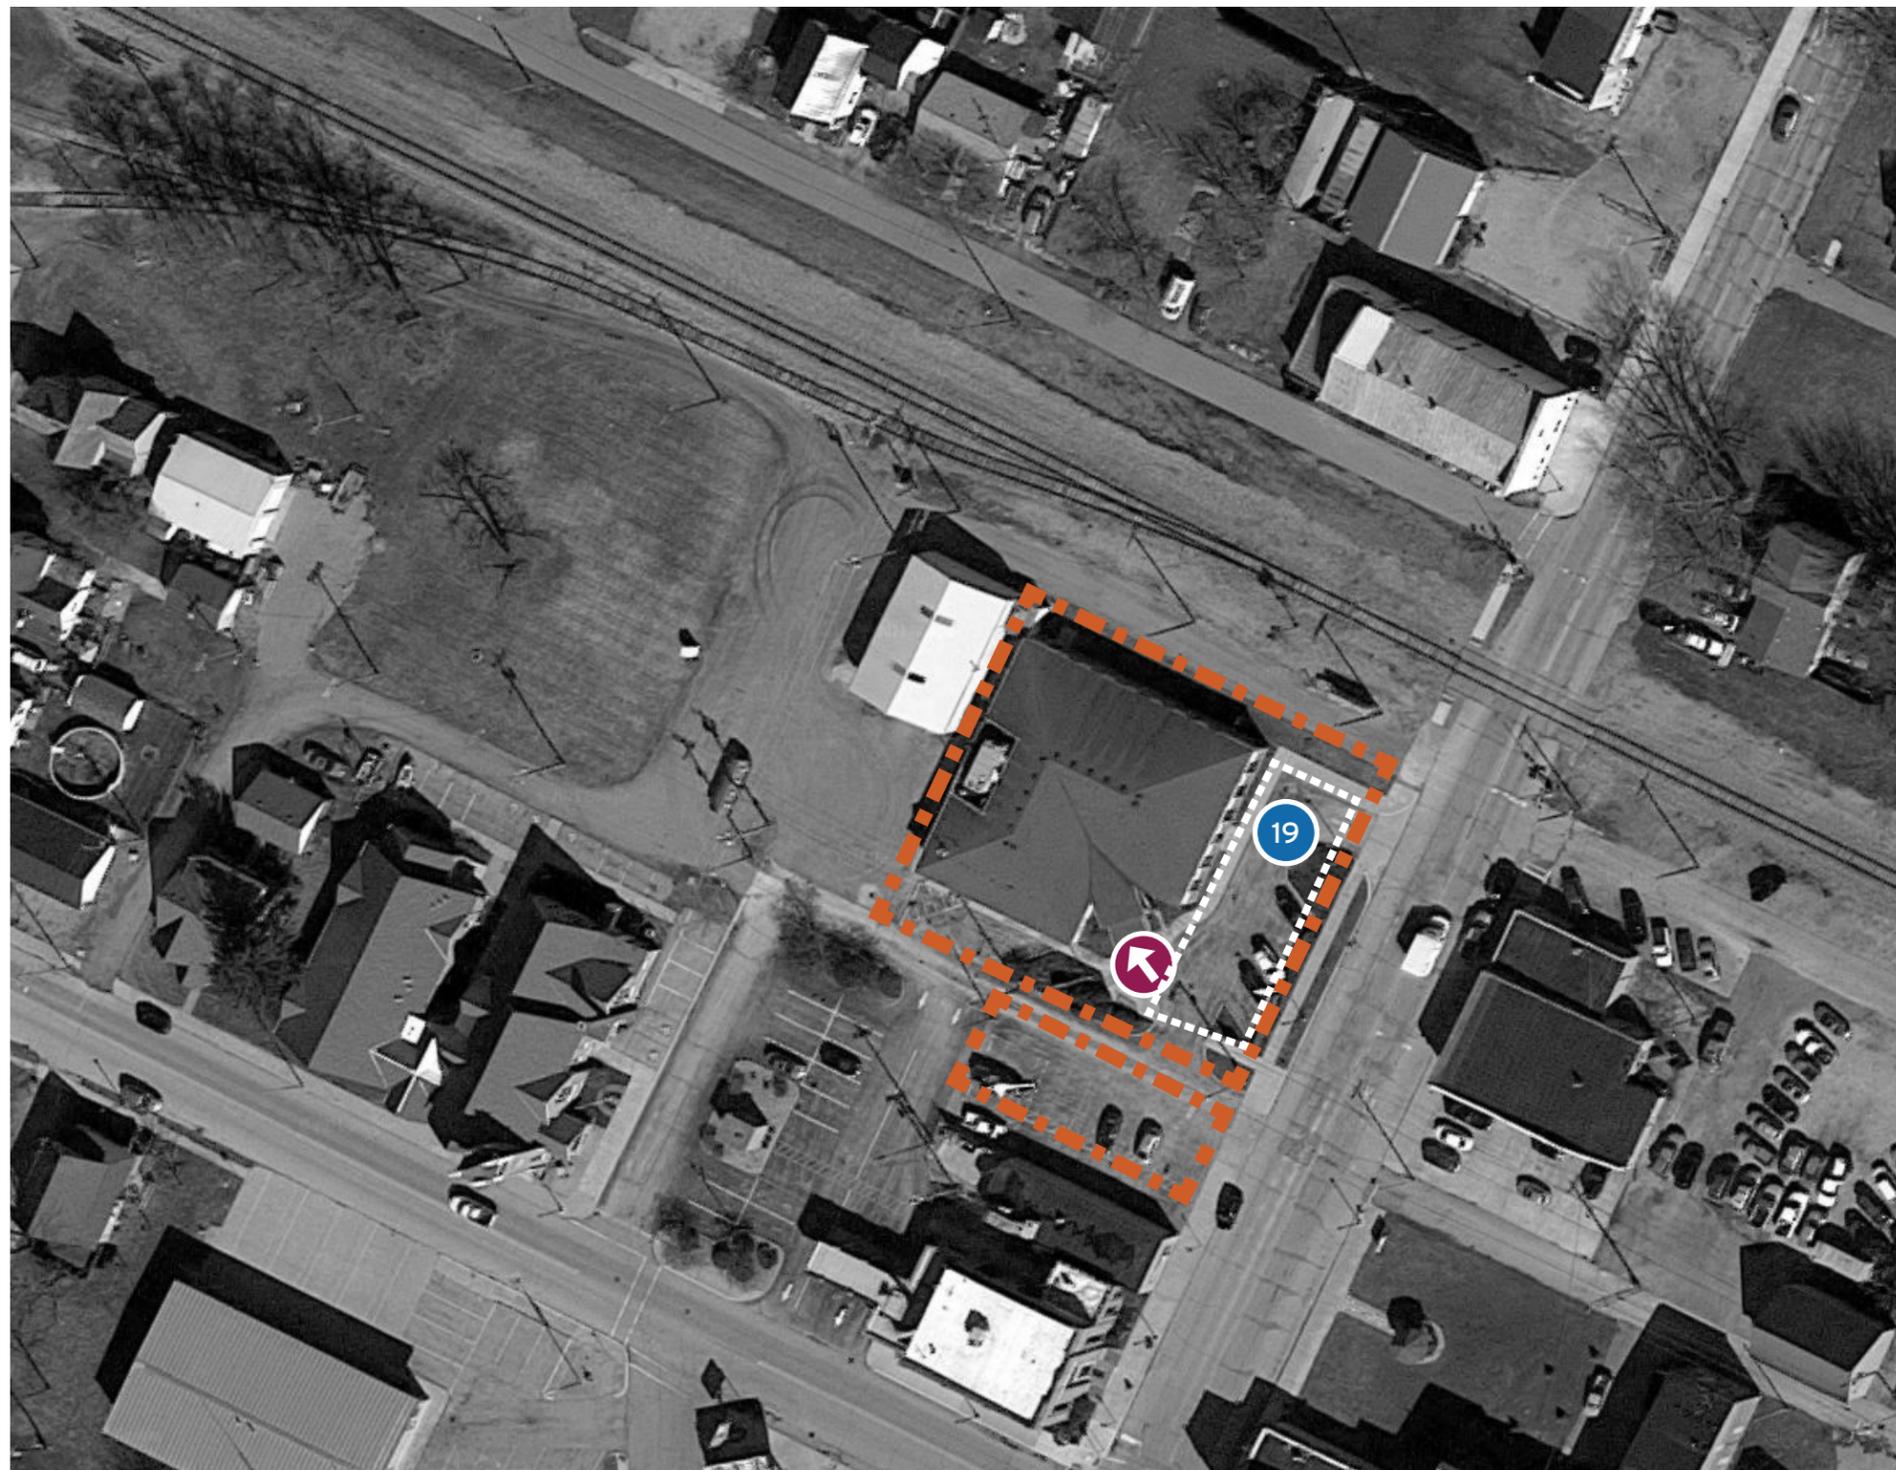
Site Plan

The branch is easily visible from Main Street in Monroeville, and it projects an adequate presence as a library.

The library property includes 14 parking spaces, with some additional spaces on a lot immediately south of the branch across an alley drive. The site includes no green space, and any outdoor programming would need to be done in the parking lot.

The property lines are very tight to the building, and they could not accommodate any expansion.

The exterior book return is on the south side of the building and not obvious to visitors.
