New Haven

GENERAL INFORMATION

BRANCH CONDITION

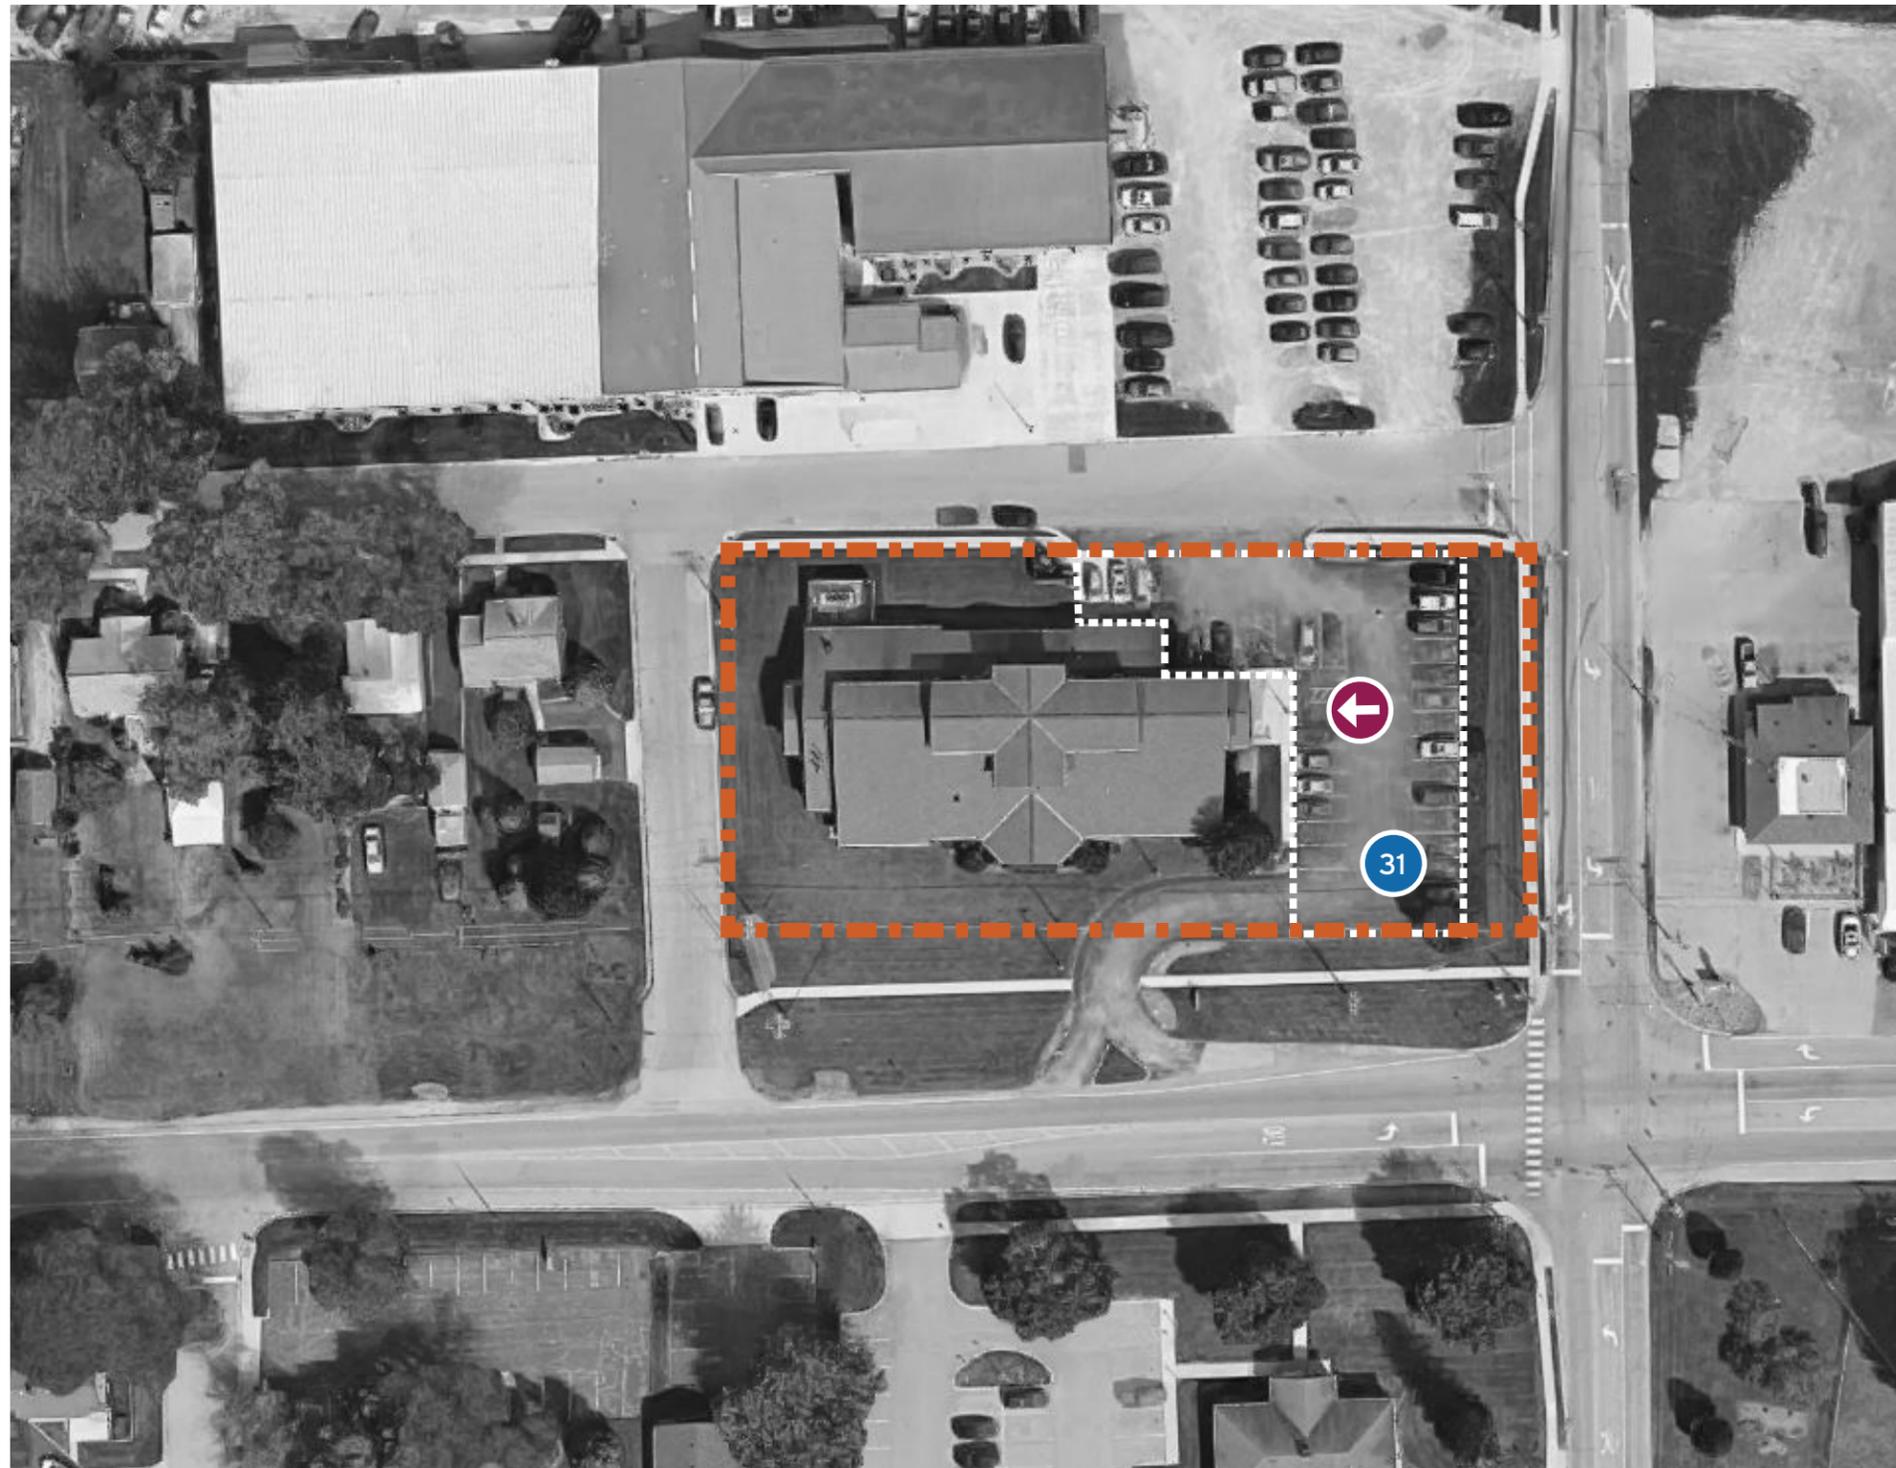
Site Plan

The branch is easily visible from Lincoln Highway and Green Street in New Haven, and it projects a good presence as a library. The building address is Green Street, however the sign is at Lincoln, and the entrances to the site are from Lincoln and Hartzell.

The parking lot includes 31 spaces, which are awkwardly configured onto the site, with challenging access from Hartzell Street and only one-way ingress/egress at Lincoln Highway. This location draws patrons with larger vehicles, which can be a challenge to accommodate with the current lot and space size. The parking access, layout and configuration are all confusing and have contributed to accidents in the lot.

Parking is also undersized for the number of cars arriving during busy times and/or for special programs and events.

The site includes some green space along the south and west sides. Lincoln Highway is a major traffic route, and it would be noisy for outdoor events. None of the green space is currently developed to accommodate programming.
