Pontiac

GENERAL INFORMATION

Address	2215 S Hanna St, Fort Wayne, IN 46803
Building Size	10,500 SF
Site Area	1.26 Acres
On Site Parking	43
Year Built	2004
Original Architect	Grinsfelder Associates

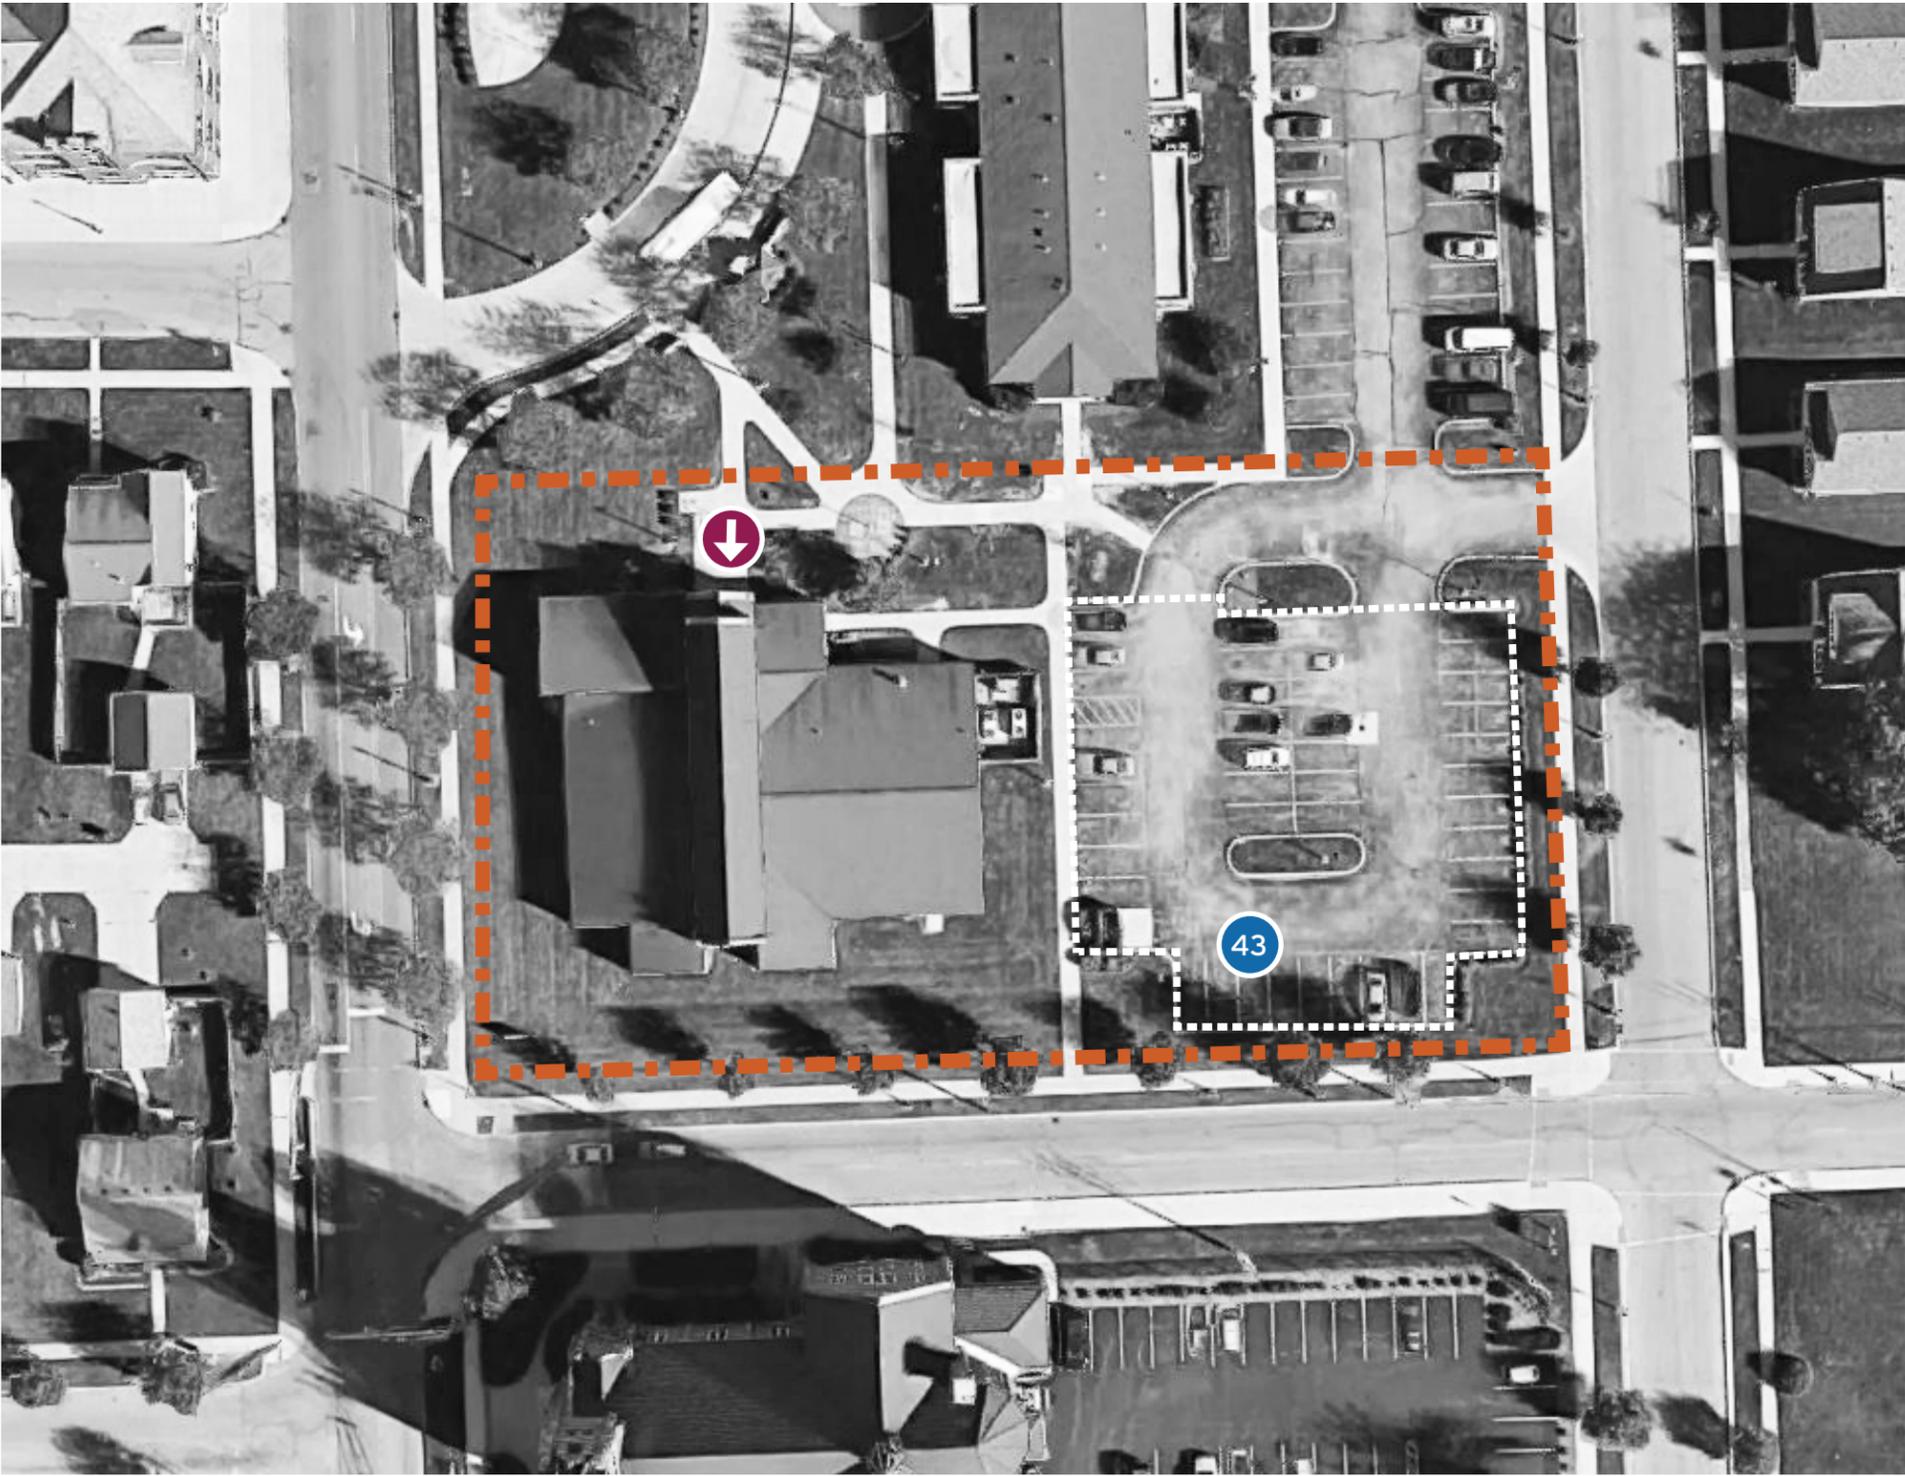
⊕ Site Plan

The branch is easily visible from Hanna Street and Creighton Avenue, and it projects a good presence although not immediately recognizable as a library. This is in part due to the location on a campus of buildings with similar architecture.

The parking lot includes 43 spaces which is adequate. Parking is accessed only off a side street Weisser Park Avenue to the east of the branch, and not directly from Hanna Street.

The main entrance is close to a drop-off drive to the north that serves other buildings for bus traffic only. This causes confusion as that drive does not lead to library parking, but is close to the entrance and off of Hanna Street, the library’s address. The distance from the parking lot to the entry is unusually far, and particularly difficult for those with mobility challenges and for all patrons during bad weather.

The site includes green space that could be developed to support outdoor programming. The site could accommodate a modest expansion of the building along the northeast and east walls.
