# Woodburn

## BRANCH CONDITION

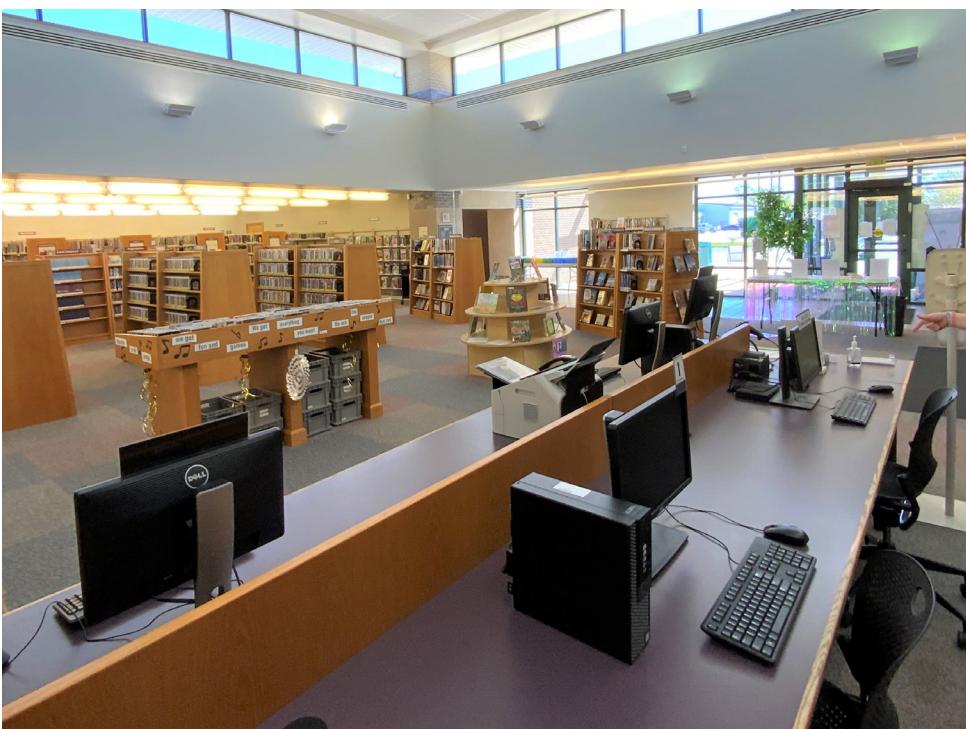
**"More accessible outlets."**
