Hessen Cassel

GENERAL INFORMATION

BRANCH CONDITION

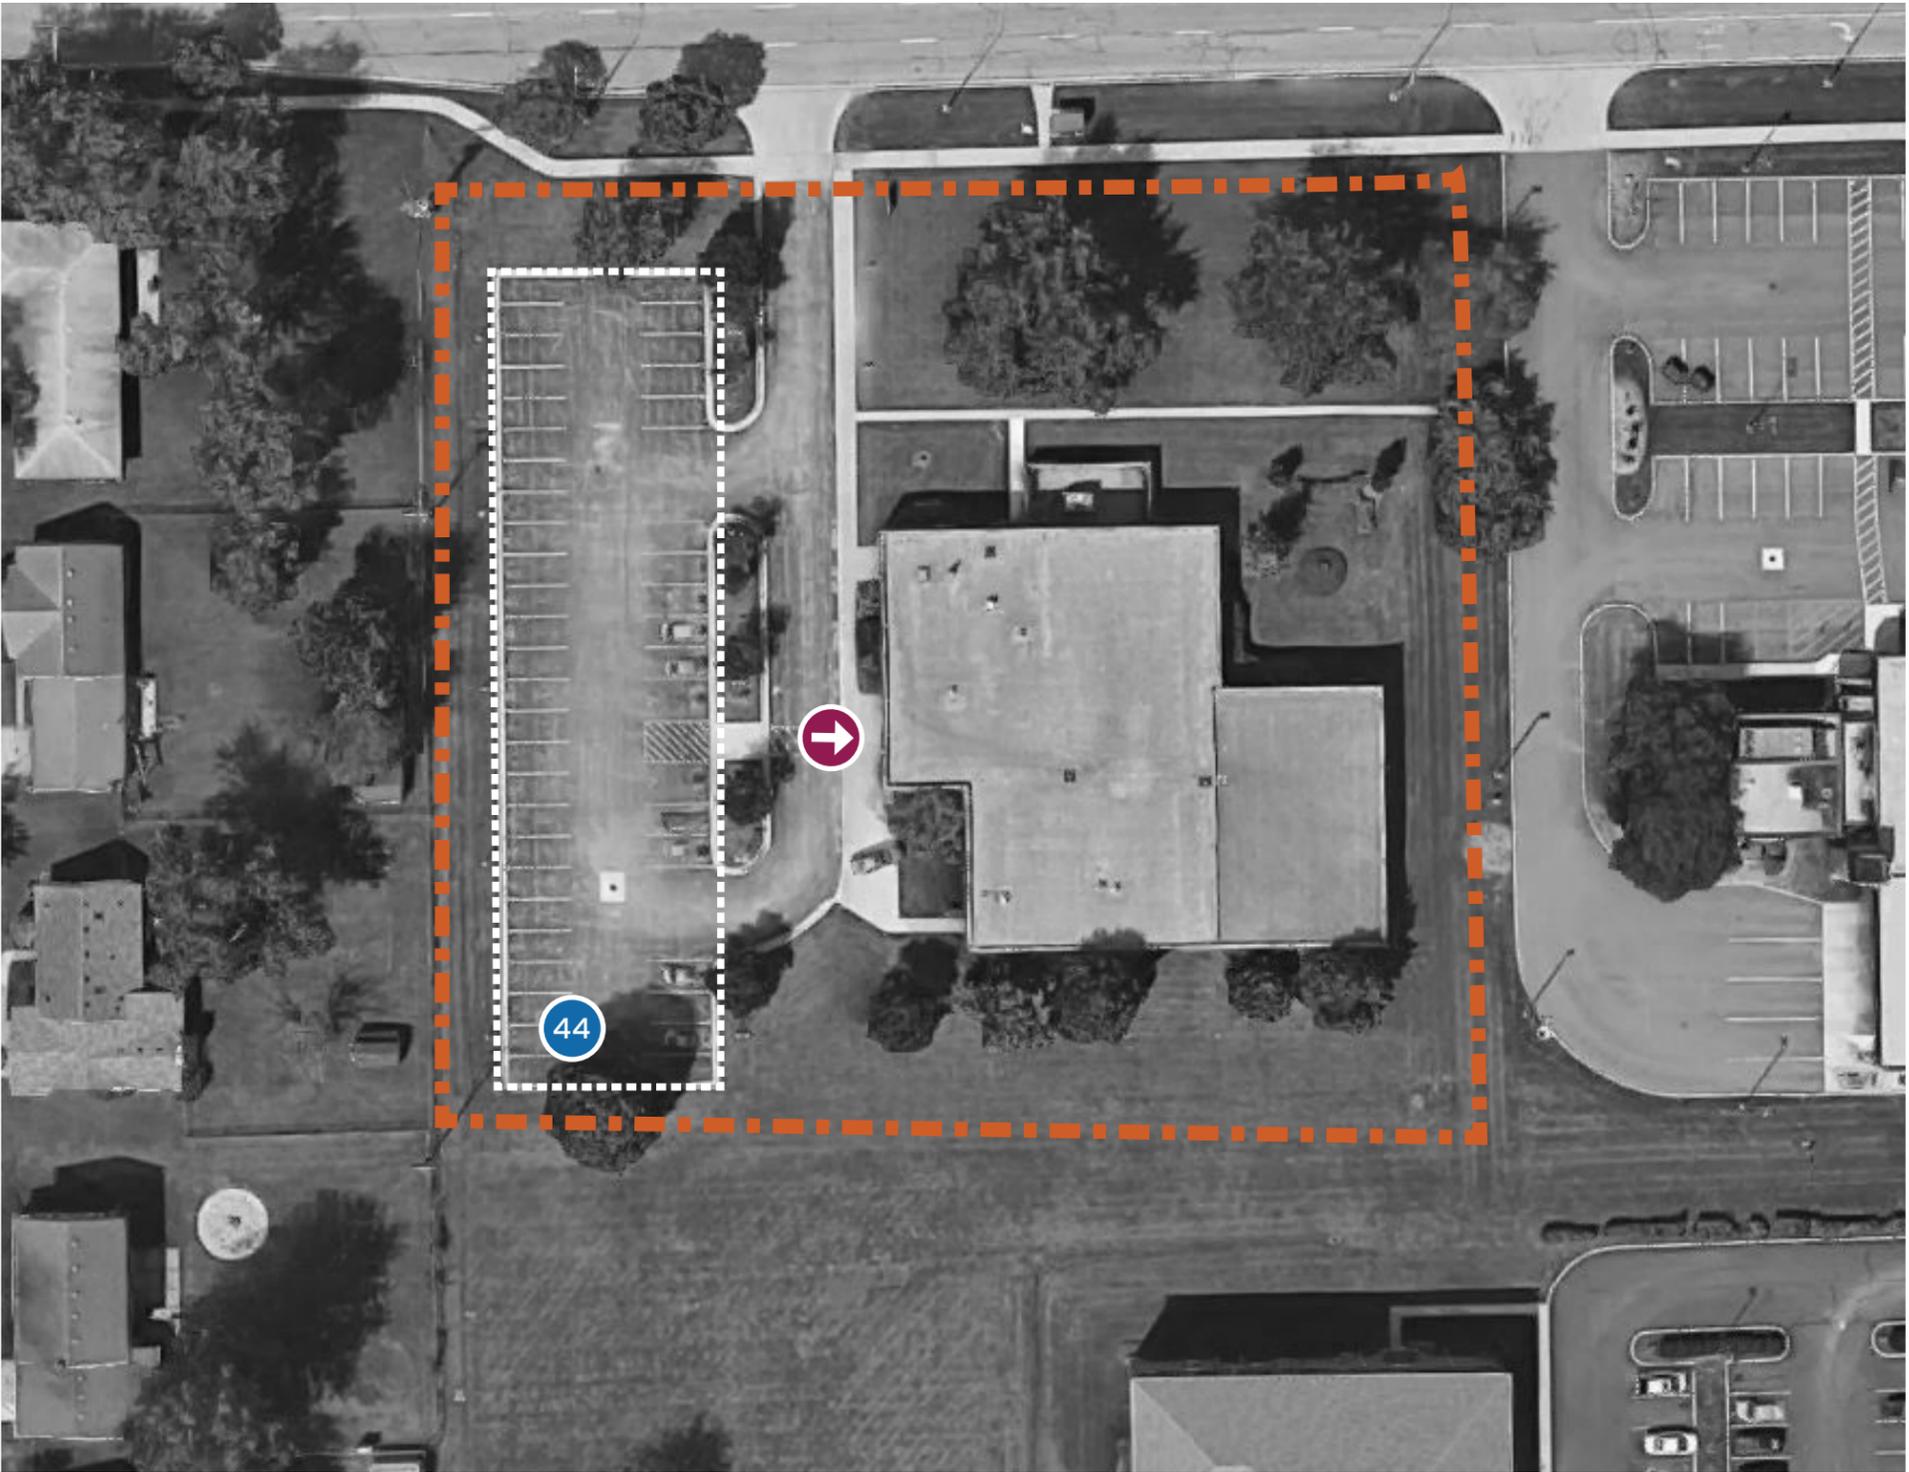
⊕ Site Plan

The branch has good visibility from East Paulding Road, and the building signage is clear. The building design does not project any presence as a library.

The parking lot includes 44 spaces, easily accessed and obvious from the street, however all parking spots are separated from the entrance by the access drive, including ADA spaces.

The site includes green space that could easily be improved for exterior programming or outdoor seating for library patrons.

The property could accommodate expansion in several locations, and original drawings specifically noted expansion capability to the south.

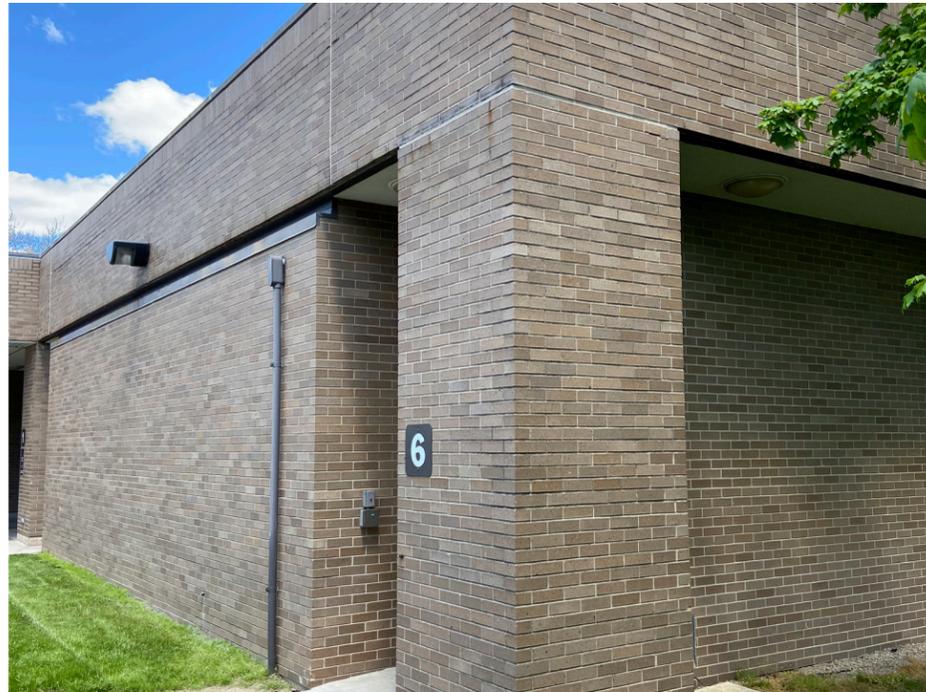
- The exterior masonry in several areas is cracking, and water infiltration has caused masonry, lintel, and exterior soffit damage at several overhangs. This condition has been noted by ACPL as a concern to be addressed.
- Doors and windows are showing signs of age and some are not functioning appropriately.
- Finishes were updated in 2006 which are showing signs of age. Where original finishes remain they are in fair condition.
- The original building pre-dates the Americans with Disabilities Act, and a survey prepared by Huntington University identified conditions that are non-compliant with the current applicable law.
