Pontiac

GENERAL INFORMATION

Address	2215 S Hanna St, Fort Wayne, IN 46803
Building Size	10,500 SF
Site Area	1.26 Acres
On Site Parking	43
Year Built	2004
Original Architect	Grinsfelder Associates

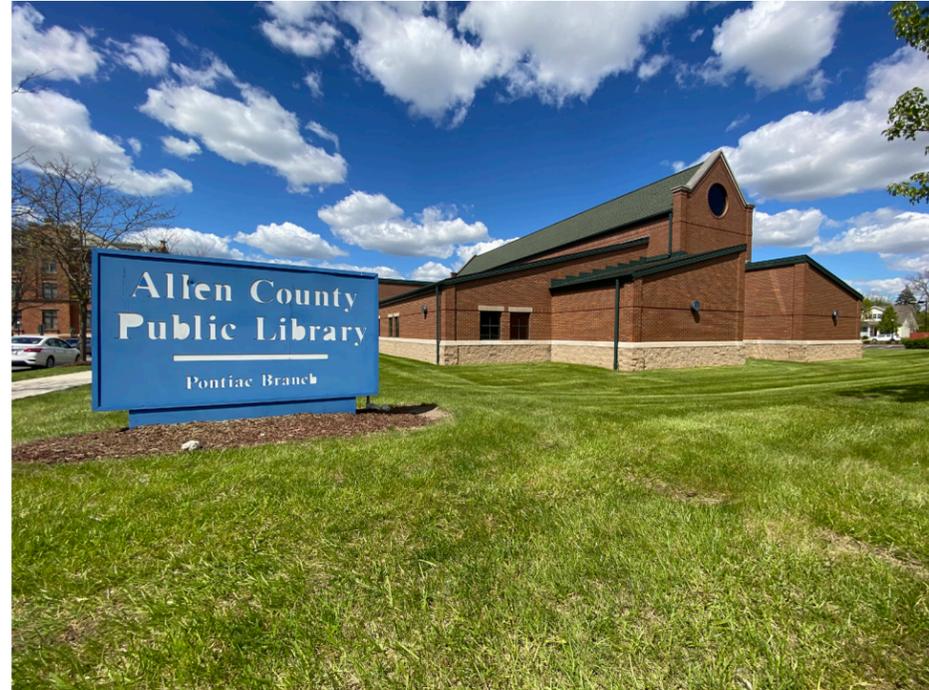
- The exterior building envelope is in decent condition, with two exceptions: the roof leaks in heavy rain, and some exterior window seals are broken allowing condensation into the airspace between panes.
- Interior finishes are original and showing signs of age and significant use, including 'shadows' in carpet where shelving has been moved, and carpet delaminating from the floor below creating some trip hazards.
- A survey prepared by Huntington University identified conditions that are non-compliant with the current applicable Americans with Disabilities Act.

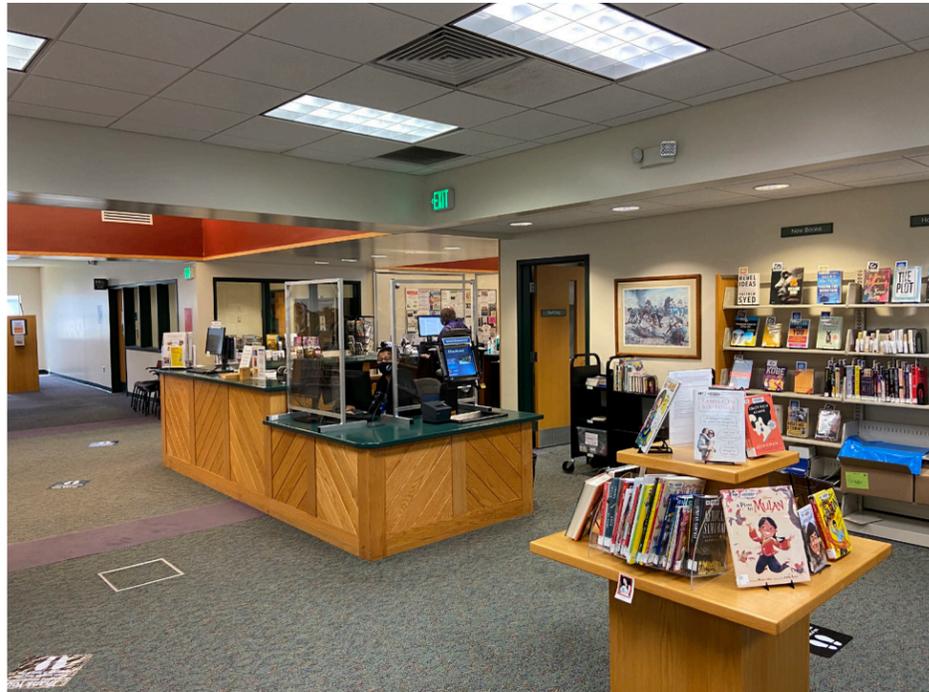
- The building is challenging to reconfigure given the floor plan and architectural features - in particular the tall central ceiling aligned with the entrance and running north-south through the building and computers noted below.

- The two built-in computer areas in the center of the branch are functional but oversized and presents a significant challenge to flexibility.
- The entrance is clear architecturally, but not obvious from the parking areas as noted above.

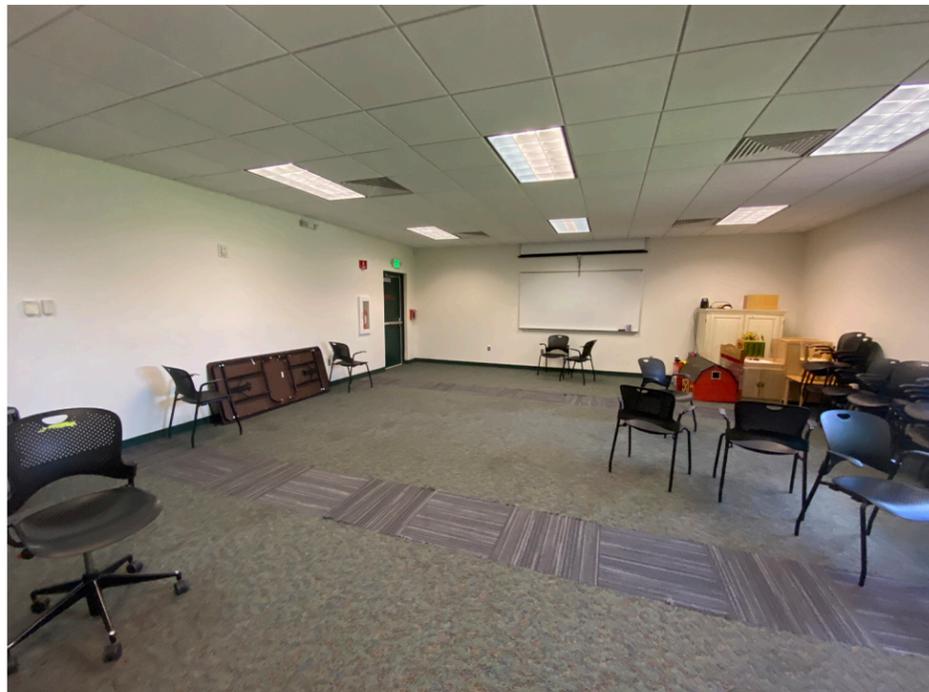
- The building configuration does not lend itself to flexibility of layout and service delivery, as noted above.
- The circulation service point is well located but is too small to properly accommodate all of the functions and services located here. The desk is also not ADA compliant.
- The staff work areas are undersized, and the space between circulation and staff work areas can be a bottleneck.
- The branch manager's office is disconnected from all other staff.
- The open book return directly into the work space should be enclosed for sound and safety.
- Staff workstations are near the exterior door. This makes it uncomfortable to work there when deliveries are being made, especially during bad weather.

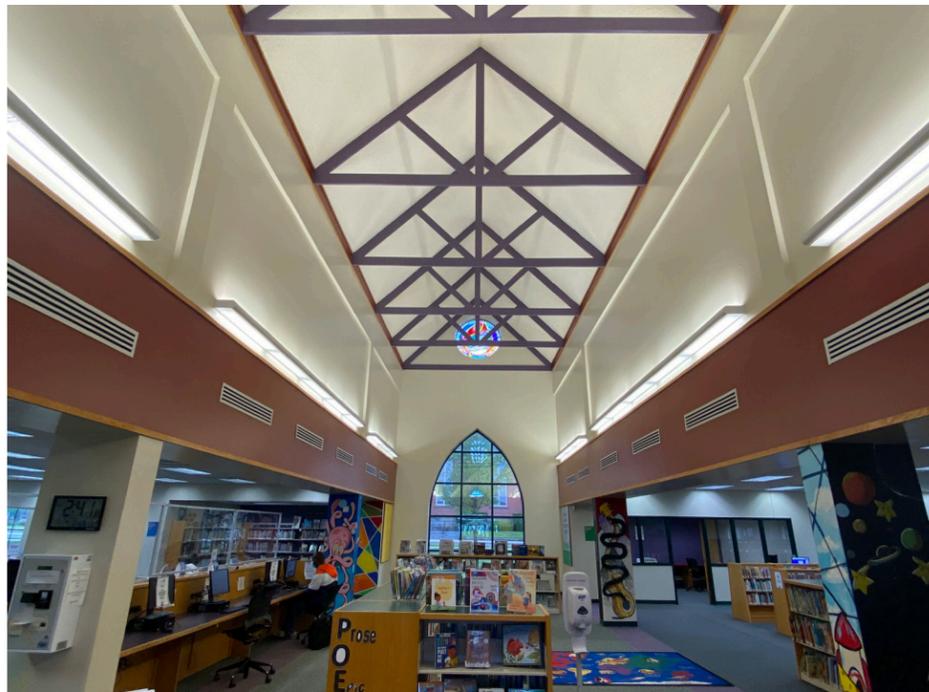
- The layout of the branch does not adequately separate quiet and loud spaces.

“This library tends to be very noisy, maybe something could be put into place to separate those who are reading or working on computers who need quiet time from the kids playing.”

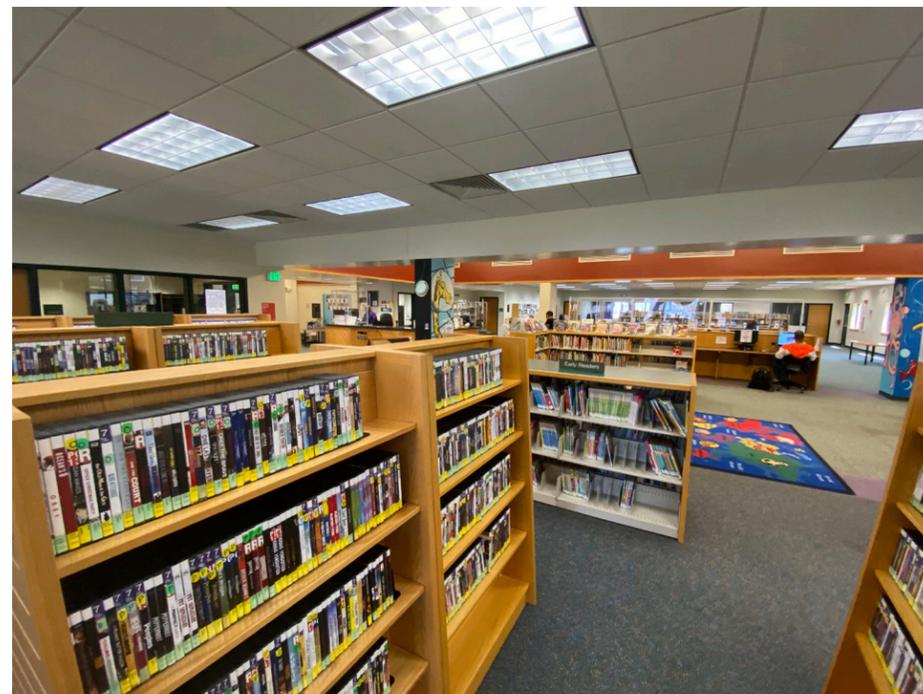
- The building is small but includes many different types of spaces. That coupled with insufficient signage results in poor wayfinding.
- The primary defining feature is the tall interior space and the stained-glass window which draws attention away from services and spaces provided in the building.
- The building includes a few targeted areas of color, and interesting murals on several columns, but there is little else to help differentiate adult, teen, and children’s spaces.
- The acoustics are problematic; loud and quiet spaces are not separated.
- The meeting room is functional, but the finishes are dated and need to be upgraded.
