# Woodburn

## BRANCH CONDITION

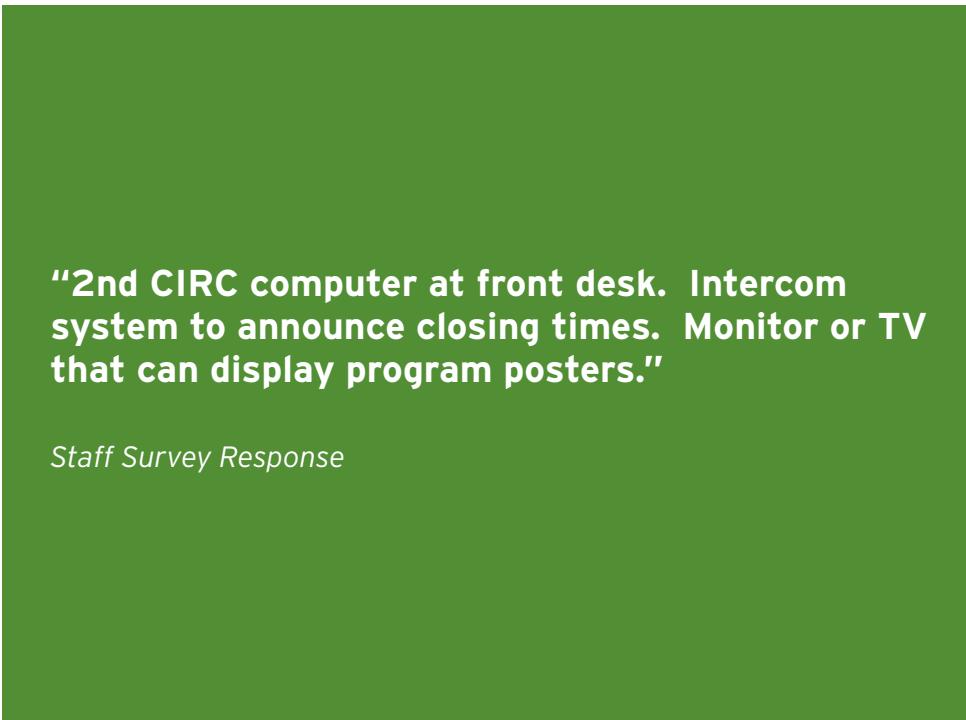
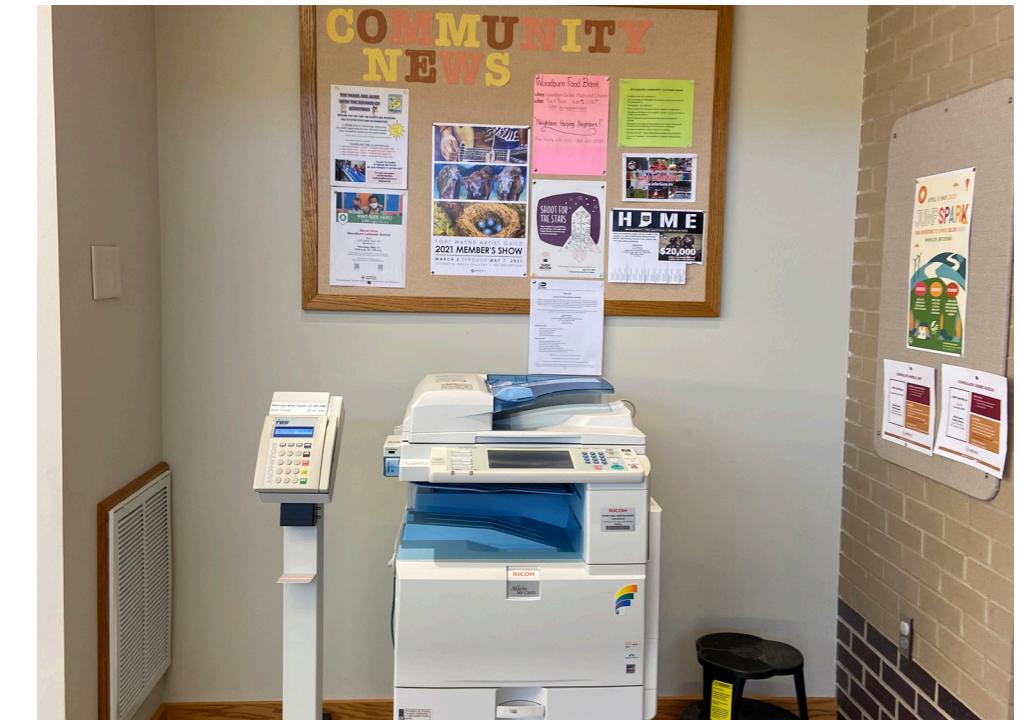
**"More accessible outlets."**
